1/2.5-Inch 8Mp Digital Image Sensor

MT9E001

Silicon Revision 1 Errata

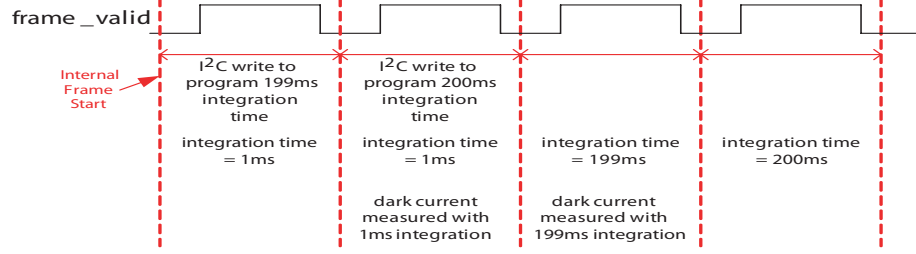
Issue#	Title Description Work Around	Details
2	Title	Dark current compensation.
	Description	<p>An integration time change will take effect on the second frame after the integration time register was programmed. However, the delta dark algorithm will use the first frame after the integration time register was programmed to measure the dark current. Hence, the delta dark algorithm will compensate for dark current based on the old integration time instead of the new integration time. This will be noticeable for large integration time changes as the dark level calculated for the new integration time will use the frame prior to when the new integration time was used.</p>

Work Around	<p>The integration time is changed in two successive frames where the first frame's integration time is only slightly different from the second. In this case, the dark level calculated for the second frame uses the prior frame that has a similar integration time, producing a very small difference in dark level. An example would be a change from 1ms to 199ms, and then to 200ms, where the ongoing dark level for 200ms would be calculated from a frame using 199ms. If the gain setting is also being changed, it should not be applied on the first of the two consecutive frames. An example is shown in the graphic below.</p>

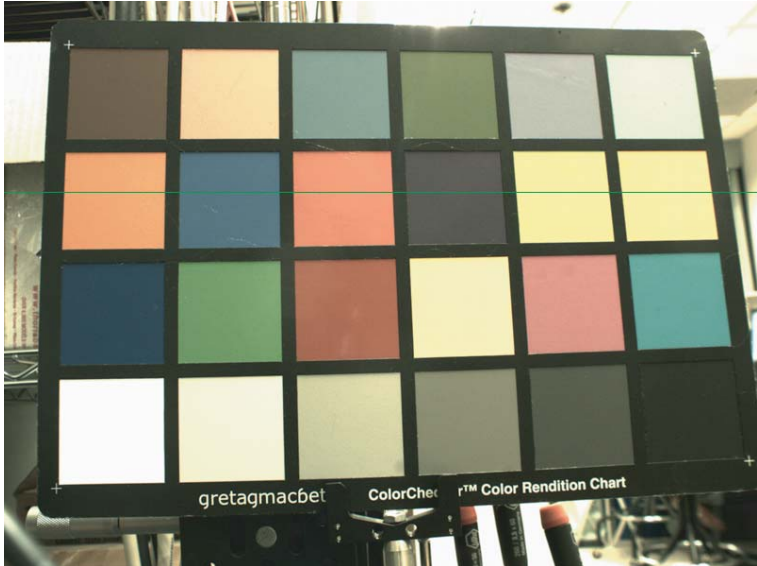
Issue#	Title Description Work Around	Details
5	Title	Intermittent video lines.
	Description	<p>Intermittent video lines can be seen in images produced by the sensor when the LSC is enabled. The unexpected line injected by the LSC feature is triggered by I²C writes. The video lines are infrequent.</p>

<p>Example of Line Seen in a Processed VGA Images</p>
	Work Around	<p>The video lines can be avoided when the LSC is enabled by only sending I²C writes to the sensor during "vertical blanking" times. The vertical blanking is a time period between the readout of each frame. The grouped_parameter_hold feature can be used to write a set of registers over multiple frames.</p>
