1/2.5-Inch 8Mp Digital Image Sensor

MT9E001

Silicon Revision 1 Errata

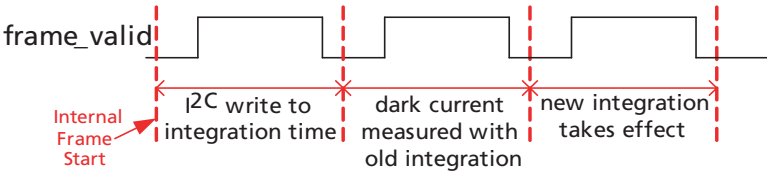
Issue #	Title Description Work Around	Details
2	Title	Dark current compensation.
	Description	<p>An integration time change will take affect on the second frame after the integration time register was programmed. However, the delta dark algorithm will use the first frame after the integration time register was programmed to measure the dark current. Hence, the delta dark algorithm will compensate dark current based on the old integration time instead of the new integration time. This will be noticeable for large integration time changes as the dark level calculated for the new integration time will use the frame prior to when the new integration time was used.</p>

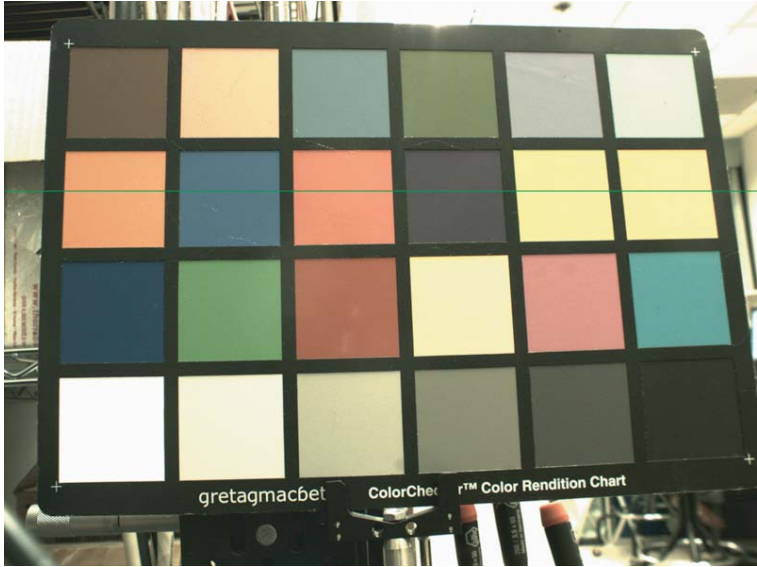
Issue #	Title Description Work Around	Details
5	Title	Intermittent video lines.
	Description	<p>Intermittent video lines can be seen in images produced by the sensor when the LSC is enabled. The unexpected line injected by the LSC feature is triggered by I²C writes. The video lines are infrequent.</p>

<p style="text-align: center;">Example of Line Seen in a Processed VGA Images</p>
	Work Around	<p>The video lines can be avoided when the LSC is enabled by only sending I²C writes to the sensor during "vertical blanking" times. The vertical blanking is a time period between the readout of each frame. The grouped_parameter_hold feature can be used to write a set of registers over multiple frames.</p>
