Technical Note

MT9P012—Optimized Register Settings

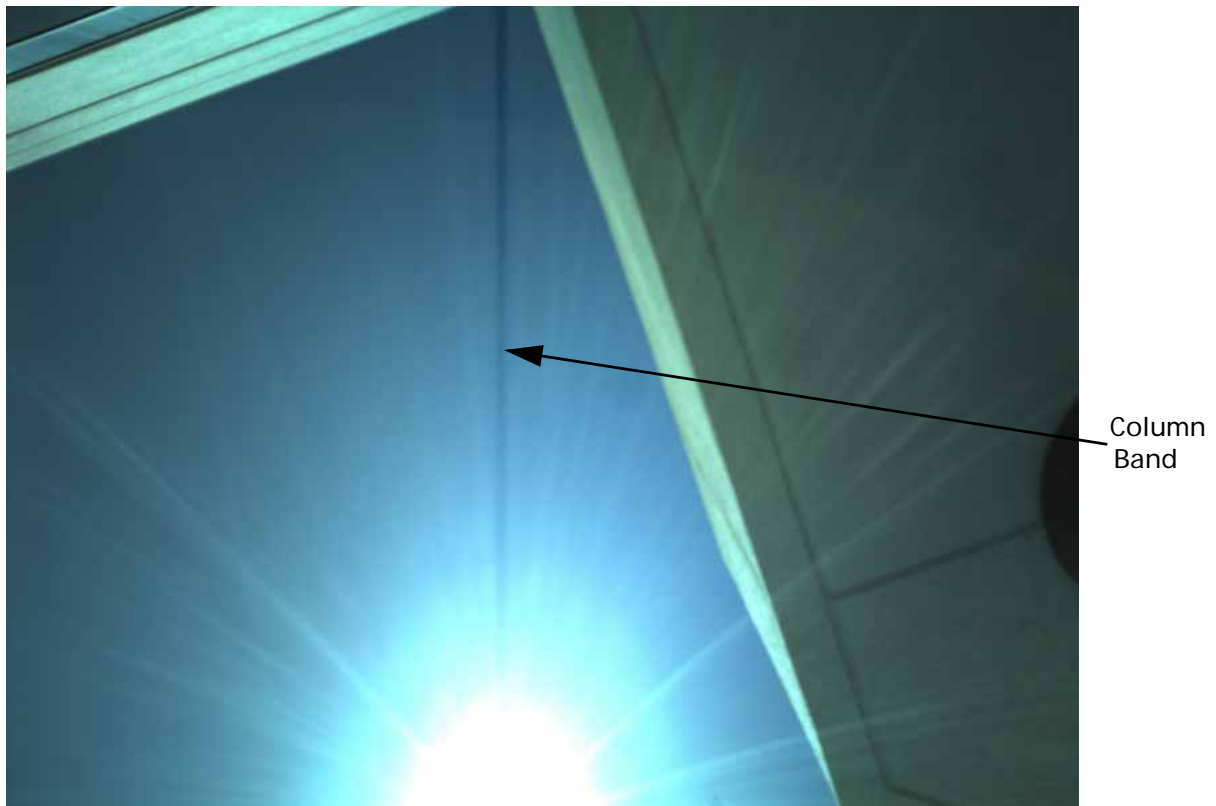
A dark band is occasionally seen across the height of the image when a bright light like the sun is directed to the bottom of the sensor array, as shown in Figure 1. This effect can be mitigated effectively by setting register bit field R0x308A[6] to 0x0000.

Figure 1: Column Band In Image with R0x308A[6] = 1 (Default)

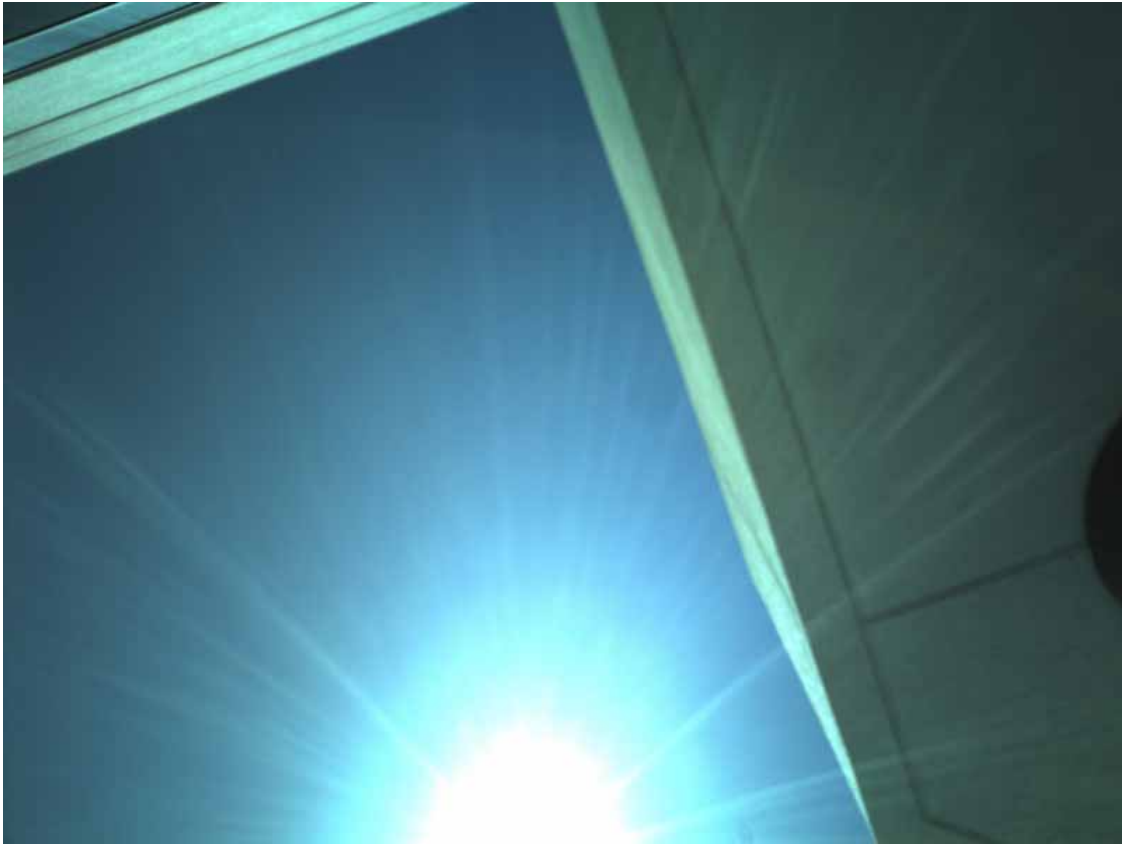
Figure 2: Column Band Eliminated with R0x308A[6] = 0
